CASE

The subject of this case study is a high school with an 18,000 square foot 16-year-old cementitious roof over 5-inch foam that was failing with extensive micro-cracking from UV attack and had required various patch repairs. In common with cementitious roofs, it has produced the tough layer of oxidation that made recoating with conventional coatings a poor prospect for a long term performance outcome.

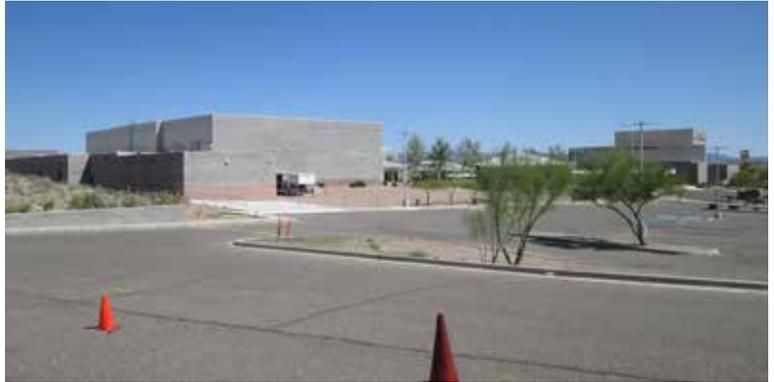
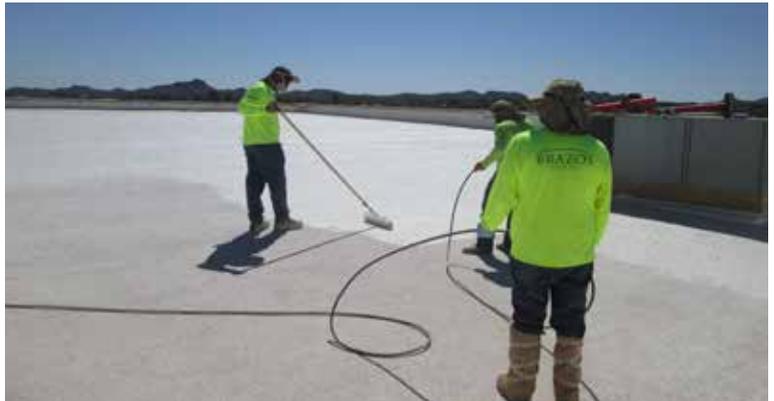
The school's gymnasium roof was surface prepped carefully with a power broom as it is only about a quarter of an inch thick. The work included removing old patches. It was then sprayed at very high pressure up to *8,000 psi with a 30 mls top coat of Ecodur and two applications on top of the Ecodur with a high reflectivity white acrylic to a total depth of 50 mls. Pot life of the Ecodur was 30-40 minutes in an average ambient temperature of about 75 degrees Fahrenheit with dry conditions.

Importantly a pull stress test of a piece of fabric laid onto the cementation roof and covered in Ecodur demonstrated the product's exceptional adhesion. The fabric could not be pulled off and finally had to be ground off.

An initial walk-over inspection of the Ecodur coating was performed after about four hours and a final inspection was conducted after 24 hours with no anomalies discovered and the project was signed off as having been completed satisfactorily
