CASE

Today, more than 12.5 billion square feet of asphalt shingle products are manufactured annually – enough to cover more than five million homes every year. Four out of five homes are roofed with asphalt shingles. This case study concerns movie theatre chain building in Arizona where high UV is tough on roofing with high temperatures inevitably causing asphalt-based materials to slowly off-gas from their bitumen content and become brittle over time. This roof was over 15 years old.

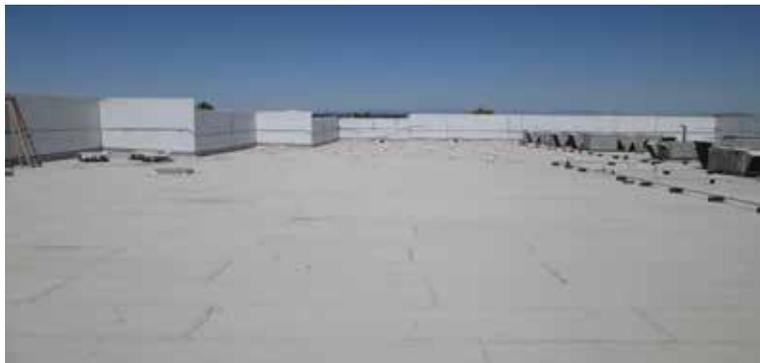
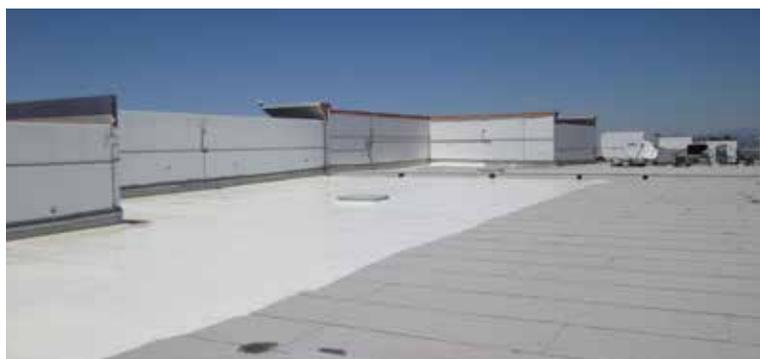
Application Results

After standard preparation to ensure that the original asphalt roofing material and overcoat was dry, clean, free of loose material and cracks, Ecodur 201M was manually applied to a depth of between 30 and 50 mils. Particular attention was paid to original seams. Ecodur creeps into any crack or gap, making an extreme bond seal and providing a 100% weather seal. The Ecodur was then over coated with 50 mils of a standard reflective and flexible acrylic roof coating paint. The Ecodur acts as a great sealer on its own and also as a super adhesive primer when used with other reflective top coat paints.

With no VOCs emanating from the Ecodur, the applicators were able to work swiftly unencumbered by uncomfortable additional safety gear that can be required for some conventional epoxy coatings that still contain VOCs. The pot life of 30-40 minutes allowed the applicators a wide time margin to get the contents of the Ecodur containers applied. Full cure was achieved in the standard period of 24 hours in the weather that remained dry with temperatures well within the normal application range. Final inspection at this point was satisfactory and the project was declared complete with no anomalies detected. The roof now has an extended 15-year life as a minimum.
