CASE STUDY: EPDM

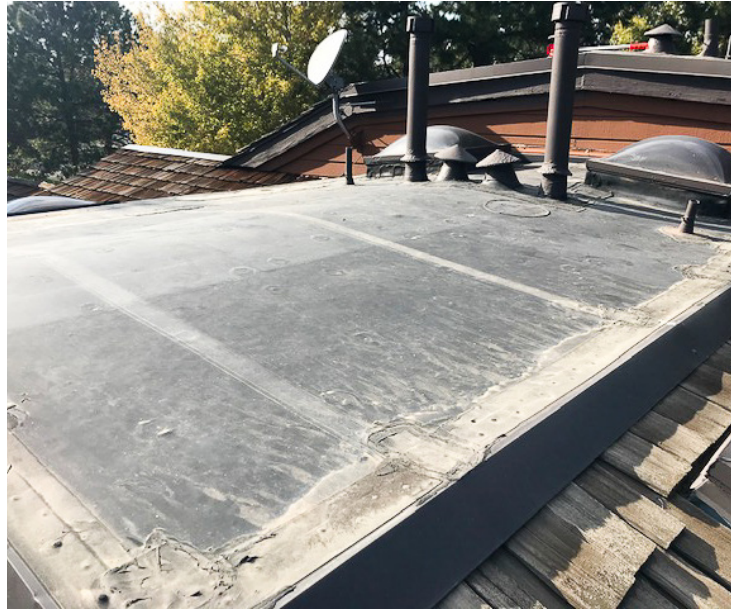
This condo complex in Denver, CO has dozens of small, aging EPDM pads. Penetrations and skylights make replacement costly, and years of failing repairs were starting to pile up. The members of the HOA did not want a coating that required pressure washing and risked further interior damage from water incursion. They wanted a solution that would require minimal tenant disruption, offer long-term water proofing, and be cost effective.

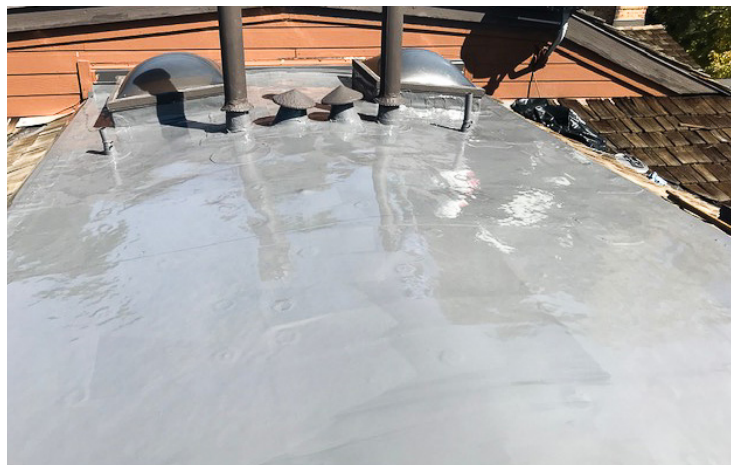
Site preparation only required sweeping and blowing the work area, requiring no down time for drying. With the project area ready to coat, the penetrations and skylight curbs were coated first.

With the penetrations and curbs complete, the remaining field and edges were quickly and easily coated with no interruption to the tenants. For the field area, application depth averaged 30 mils, with some variation at the penetrations.

This repair is ready to repel water immediately, and will fully cure in approximately 12 hours.
