CASE STUDY: CHANDLER CHURCH

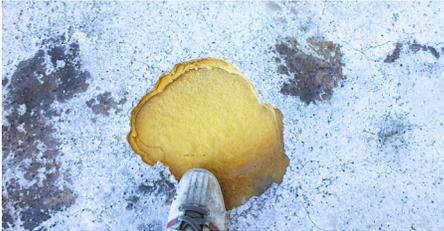
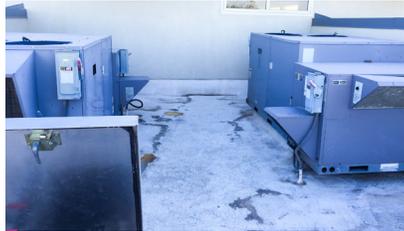
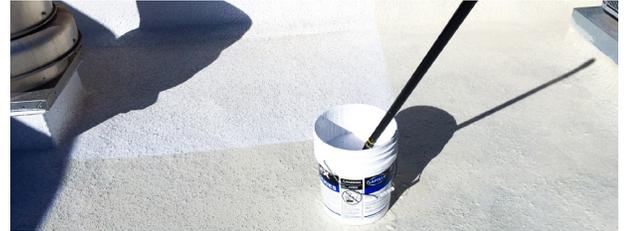
As cementitious roofing ages, it tends to crack significantly and chalk, creating a surface that most coatings cannot adhere to. For this church in Chandler, AZ, tear off and replacement was not a viable option due to the multitude of HVAC units housed on the small roofing section. Disconnecting the HVAC units, even for a couple of days, would be highly disruptive to church business in the hot desert summer.

Only minimal site preparation was required to ready the project area. The entire surface was swept and blown with all ponding areas scrubbed, and all blisters were cut out. With preparation complete, the roofers started in on detail work such as edging, penetrations, HVAC curbs, and blister filling. Because Ecodur has no maximum mil thickness, it easily fills cracks, voids, and blisters.

Ecodur was then applied to the remaining field area. Ecodur filled the many cracks and soaked in deep prior to curing.

Next, the first pass of an acrylic topcoat was applied. The topcoat will provide reflectivity in the intense desert sun and help keep the building and equipment cool.

An anti-skid additive of ground limestone was broadcast by hand into the first coat. This will provide grip in case any of the mechanical equipment needs servicing in wet weather.

Finally, the acrylic topcoat is applied for a seamless, reflective look.
