## PROBLEM

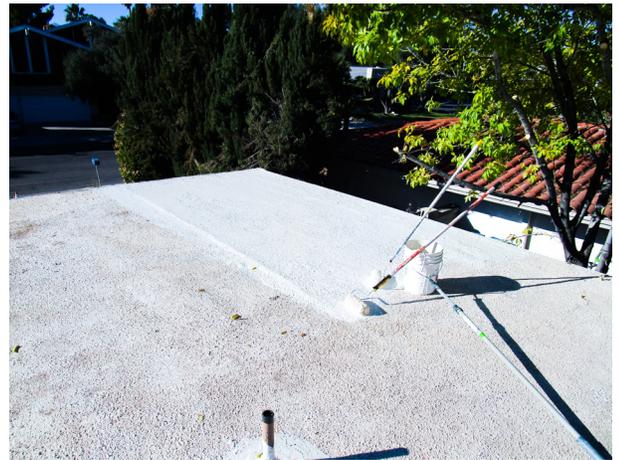
Having purchased the home only 7 months ago, the client had just gotten their first rain. They were shocked to find that the flat portion of their roof leaked everywhere including right in the middle of the living room. About a year ago, the previous owner had hired a poorly executed repair consisting of simply moving the gravel, applying a layer of acrylic, and replacing the gravel. This may have been a cheap fix, but failed to permanently address the 14 sheets of sheathing requiring replacement and the acrylic quickly broke down in the low ponding areas covering approximately 1/4 of the roof.

Adhesion tests were performed, proving that Ecodur bonds completely to the existing substrate with no need for a primer. Because of its ability to bond to a variety of materials, Ecodur was a perfect choice for the tie ins needed to facilitate the repairs. Because of Ecodur's extreme adhesion, the contractor was able to apply without pressure washing, preventing any further water damage to the interior of the home.
