CASE STUDY: VA PROJECT

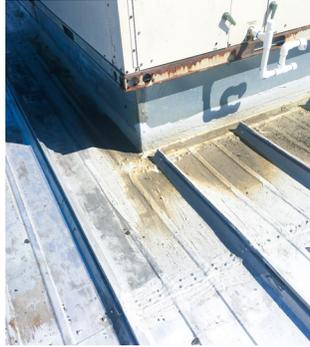
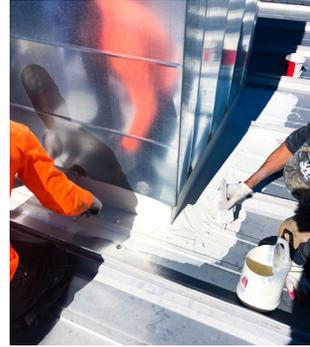
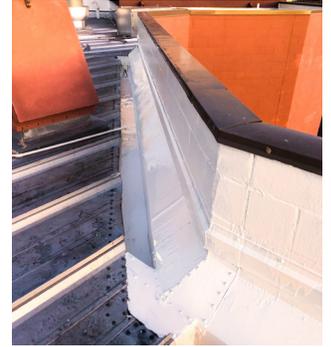
This shopping plaza in Fairfax, VA has a low-slope metal roof that was in mostly good shape. However, tenants were reporting leaks at HVAC ducting and other penetrations. The mastics that had been used for previous repairs aged quickly and cracked or peeled, causing the leaks to return. The frustrated property manager and tenants sought a better, permanent solution. Further complicating the search for a proper seal is the plan to coat the entire roof in a reflective coating within the next 5 years. This made it imperative the coating used for patching not prevent adhesion when the reflective coat is applied.

Site preparation only required sweeping and blowing the work area, requiring no down time for drying. With the project area ready to coat, the penetrations were coated first and crushed walnut was used to thicken the Ecodur for filling gaps.

The workers then moved on to a brick parapet wall leading into a gutter that was also fully coated. Thickness varied from 20 mils on the vertical wall to over 100 mils to fill larger gaps.
